Mobile Intel® Celeron® Processor at 466 MHz, 433 MHz, 400 MHz, 366 MHz, 333 MHz, 300 MHz, and 266 MHz Specification Update

Release Date: August 2002

Order Number: 244444-035

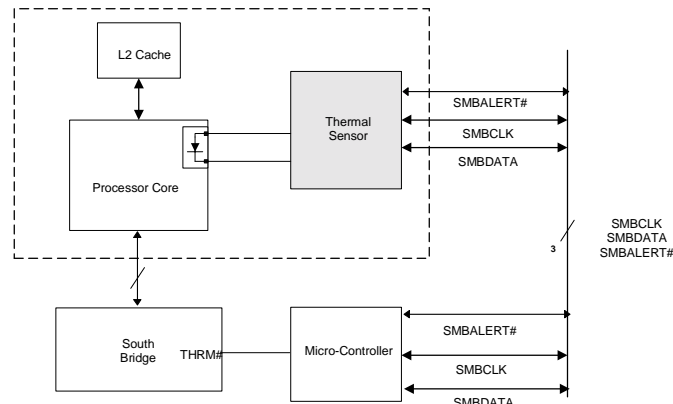
Figure 1. An Example of Microcontroller Driven Thermal Management

H29. Thermal Sensor May Assert SMBALERT# Incorrectly

Problem: The Intel Celeron Processor Mobile Module has a thermal sensor that monitors the processor core's temperature. Please note that desktop systems could have a similar thermal device. The thermal sensor asserts SMBALERT# if the processor temperature exceeds the temperature limits set in the Alarm Threshold Registers (T_{HIGH} , T_{LOW}). It also sets the corresponding Status Register bits to identify the cause of the interrupt. Figure 1 gives one example of the how the SMBALERT# signal could be used in a system.

Implication: There is no system impact from this erratum if temperature polling is used for processor thermal management. If the SMBALERT# interrupt is employed to manage processor thermal sensing, then servicing the false interrupt may result in premature system action depending on the software and hardware implementations used. The rate of the false interrupts is less than the auto-convert rate of the thermal sensor.
